# **AIS Survey: Rainbow Lake Targeted Partial Survey**

# 2025 Rainbow Lake Targeted Partial Aquatic Invasive Species Survey

Ezra Schwartzberg, Ph.D., Tucker Jakobe, and Olivia Kardohely  
Adirondack Research  
July 2025

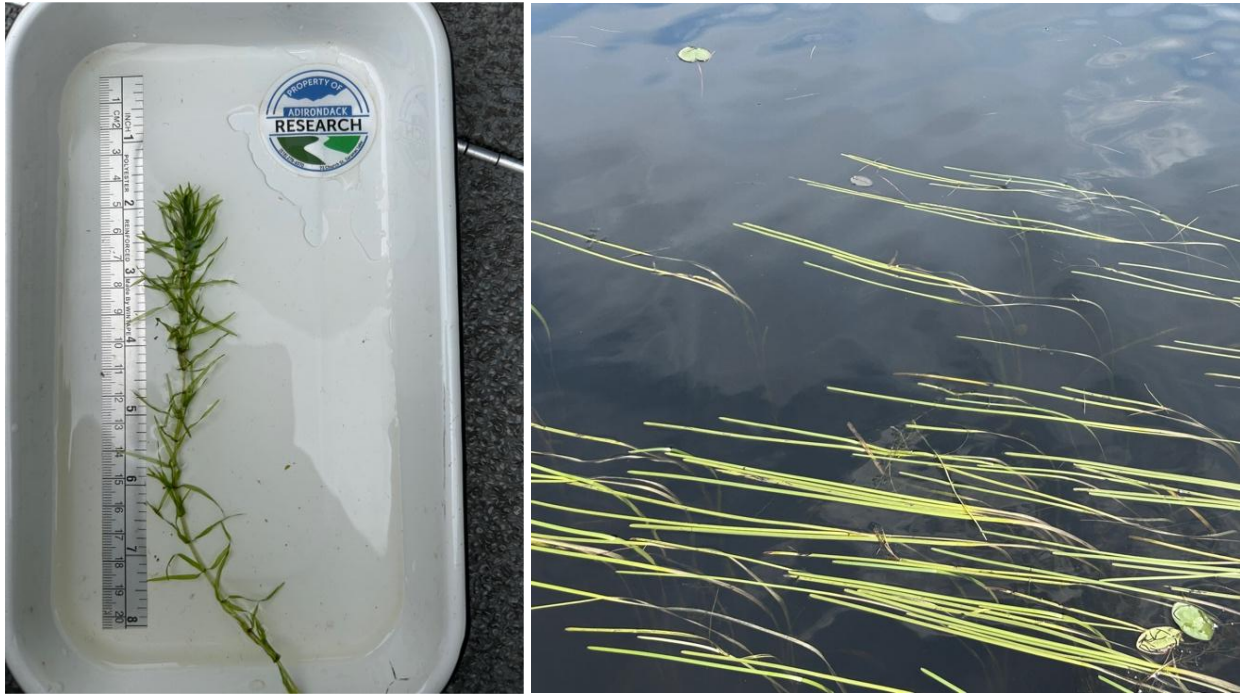
**Photos (from left):** Native Canadian Waterweed (*Elodea spp.*), Native Eel Grass (*Vallisneria americana*) and Native Watershield (*Brasenia schreberi*)

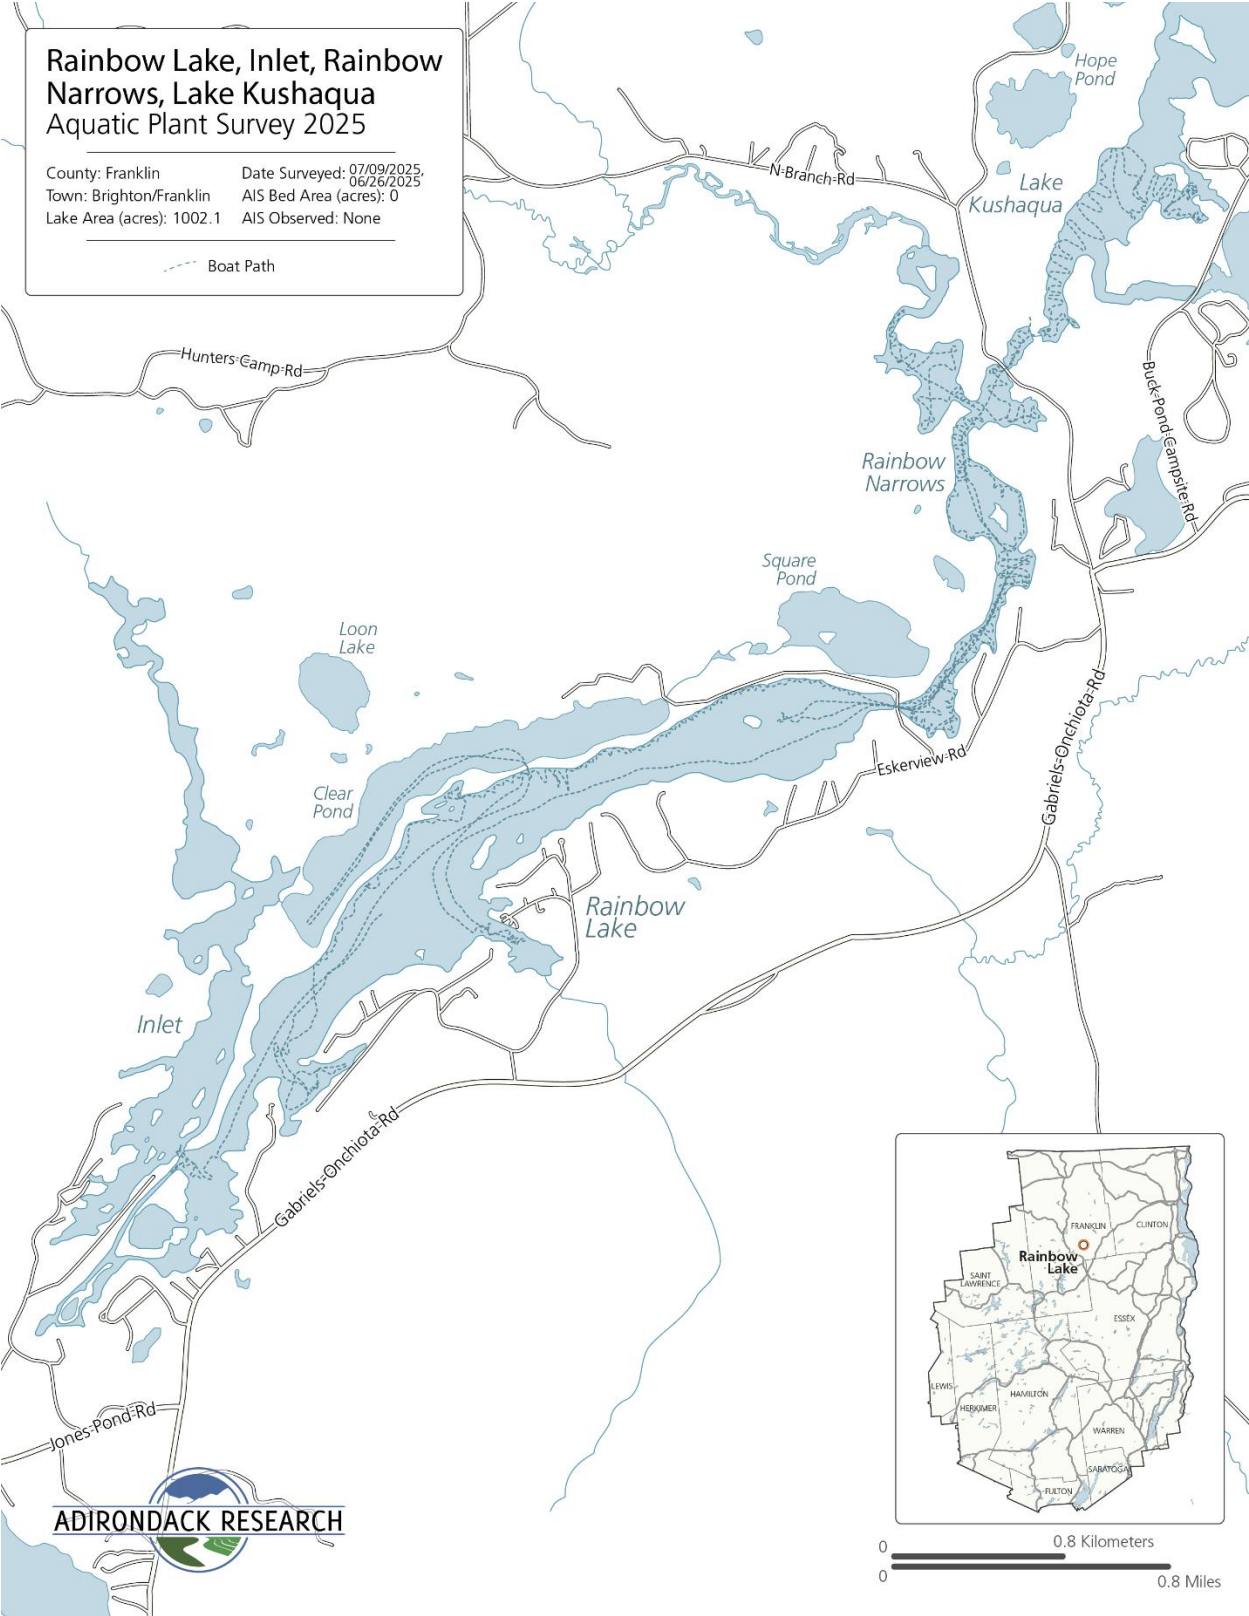
## Rainbow Lake

The map included in this report has been created using publicly accessible data showing roads and lake boundary. When available, we also include publicly accessible bathymetry data from the NYS DEC. If found, invasive plant beds are also shown on the included map. Raw sonar data files from our survey can be supplied to you if requested. The dotted line on the maps shows our survey path this year.

Rainbow Lake is 362 acres with approximately 11.7 miles of shoreline. It is located in the Town of Rainbow Lake in Franklin County, in the Saranac River watershed. The team launched one motorboat at a public launch.

No invasives detected.
